Restoration Report

Identification; WAF A03	Grade II listed, ID 251280
Location NGR; SU 36113 90115	Vale of White Horse, Parish of West Challow; A417, Faringdon Road; just beyond brow, west of Hill House
Design & material	Faringdon Tombstone – Type 2 bevelled top edge with straighter side - rectangular cross section, segmental top with slightly sloping sides and slightly concave front face and bevel to top edge. Made of porous limestone with no obvious bedding planes
Date	Assumed to be early 19 th century – design used on several turnpikes so maybe commissioned by Highways Board

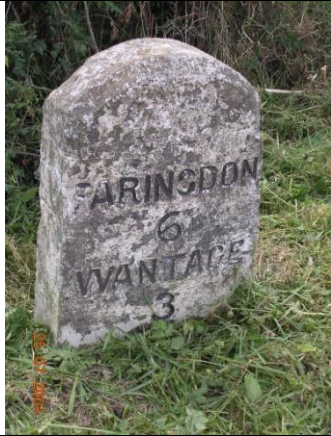
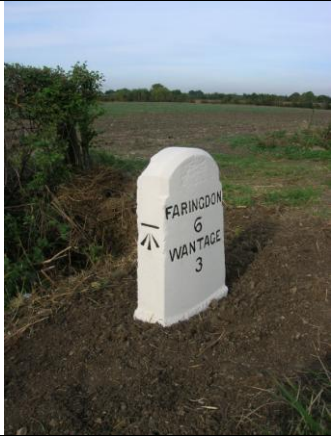
<i>Prior to Restoration</i>	<i>After Restoration</i>
Restoration work by Alan Rosevear, Aug 2005.

Dimension	Was 50 high	width slopes from 36 at top to 42 at base; 14 deep and 68 high (dressed to 63 high); letters 5h, number 6h
Condition of stone	Stone had sunk or been buried by added soil	Skimmed grass and soil to bring level to that intended around the stone. Silicate filler used to repair small chip to letters on left front.
Condition of coating & letters	Clear Incised letters and numbers. Bench mark on left side. Recent oil based paint has detached. Discontinuous layer of old oil paint Black/on/white with residues of old green layer	Stone scraped but old oil layers needed paint stripper to remove to porous condition. Scrubbed to remove lime residues. Stone painted with 2 coats of 20% diluted Keim Granital and one coat of off-white Keim top coat. Letters painted in black Sandtex
Notes on Work	Continuous film of old paint could only be fully broken with paint stripper. No need to use algicide after this. Back left unpainted.

Area around stone cut back	Area around stone cleared	Minor filling after removal of oil paint	Painted white prior to lettering
